California State Board of Equalization
450 N Street, Sacramento, California

Mold Remediation – 11th Floor
Closure Report Addendum (Revised)
Project No. 2372.02-572

Closure Report Date: December 8, 2009
Addendum Date: October 31, 2012
Addendum Revision Date: January 9, 2013

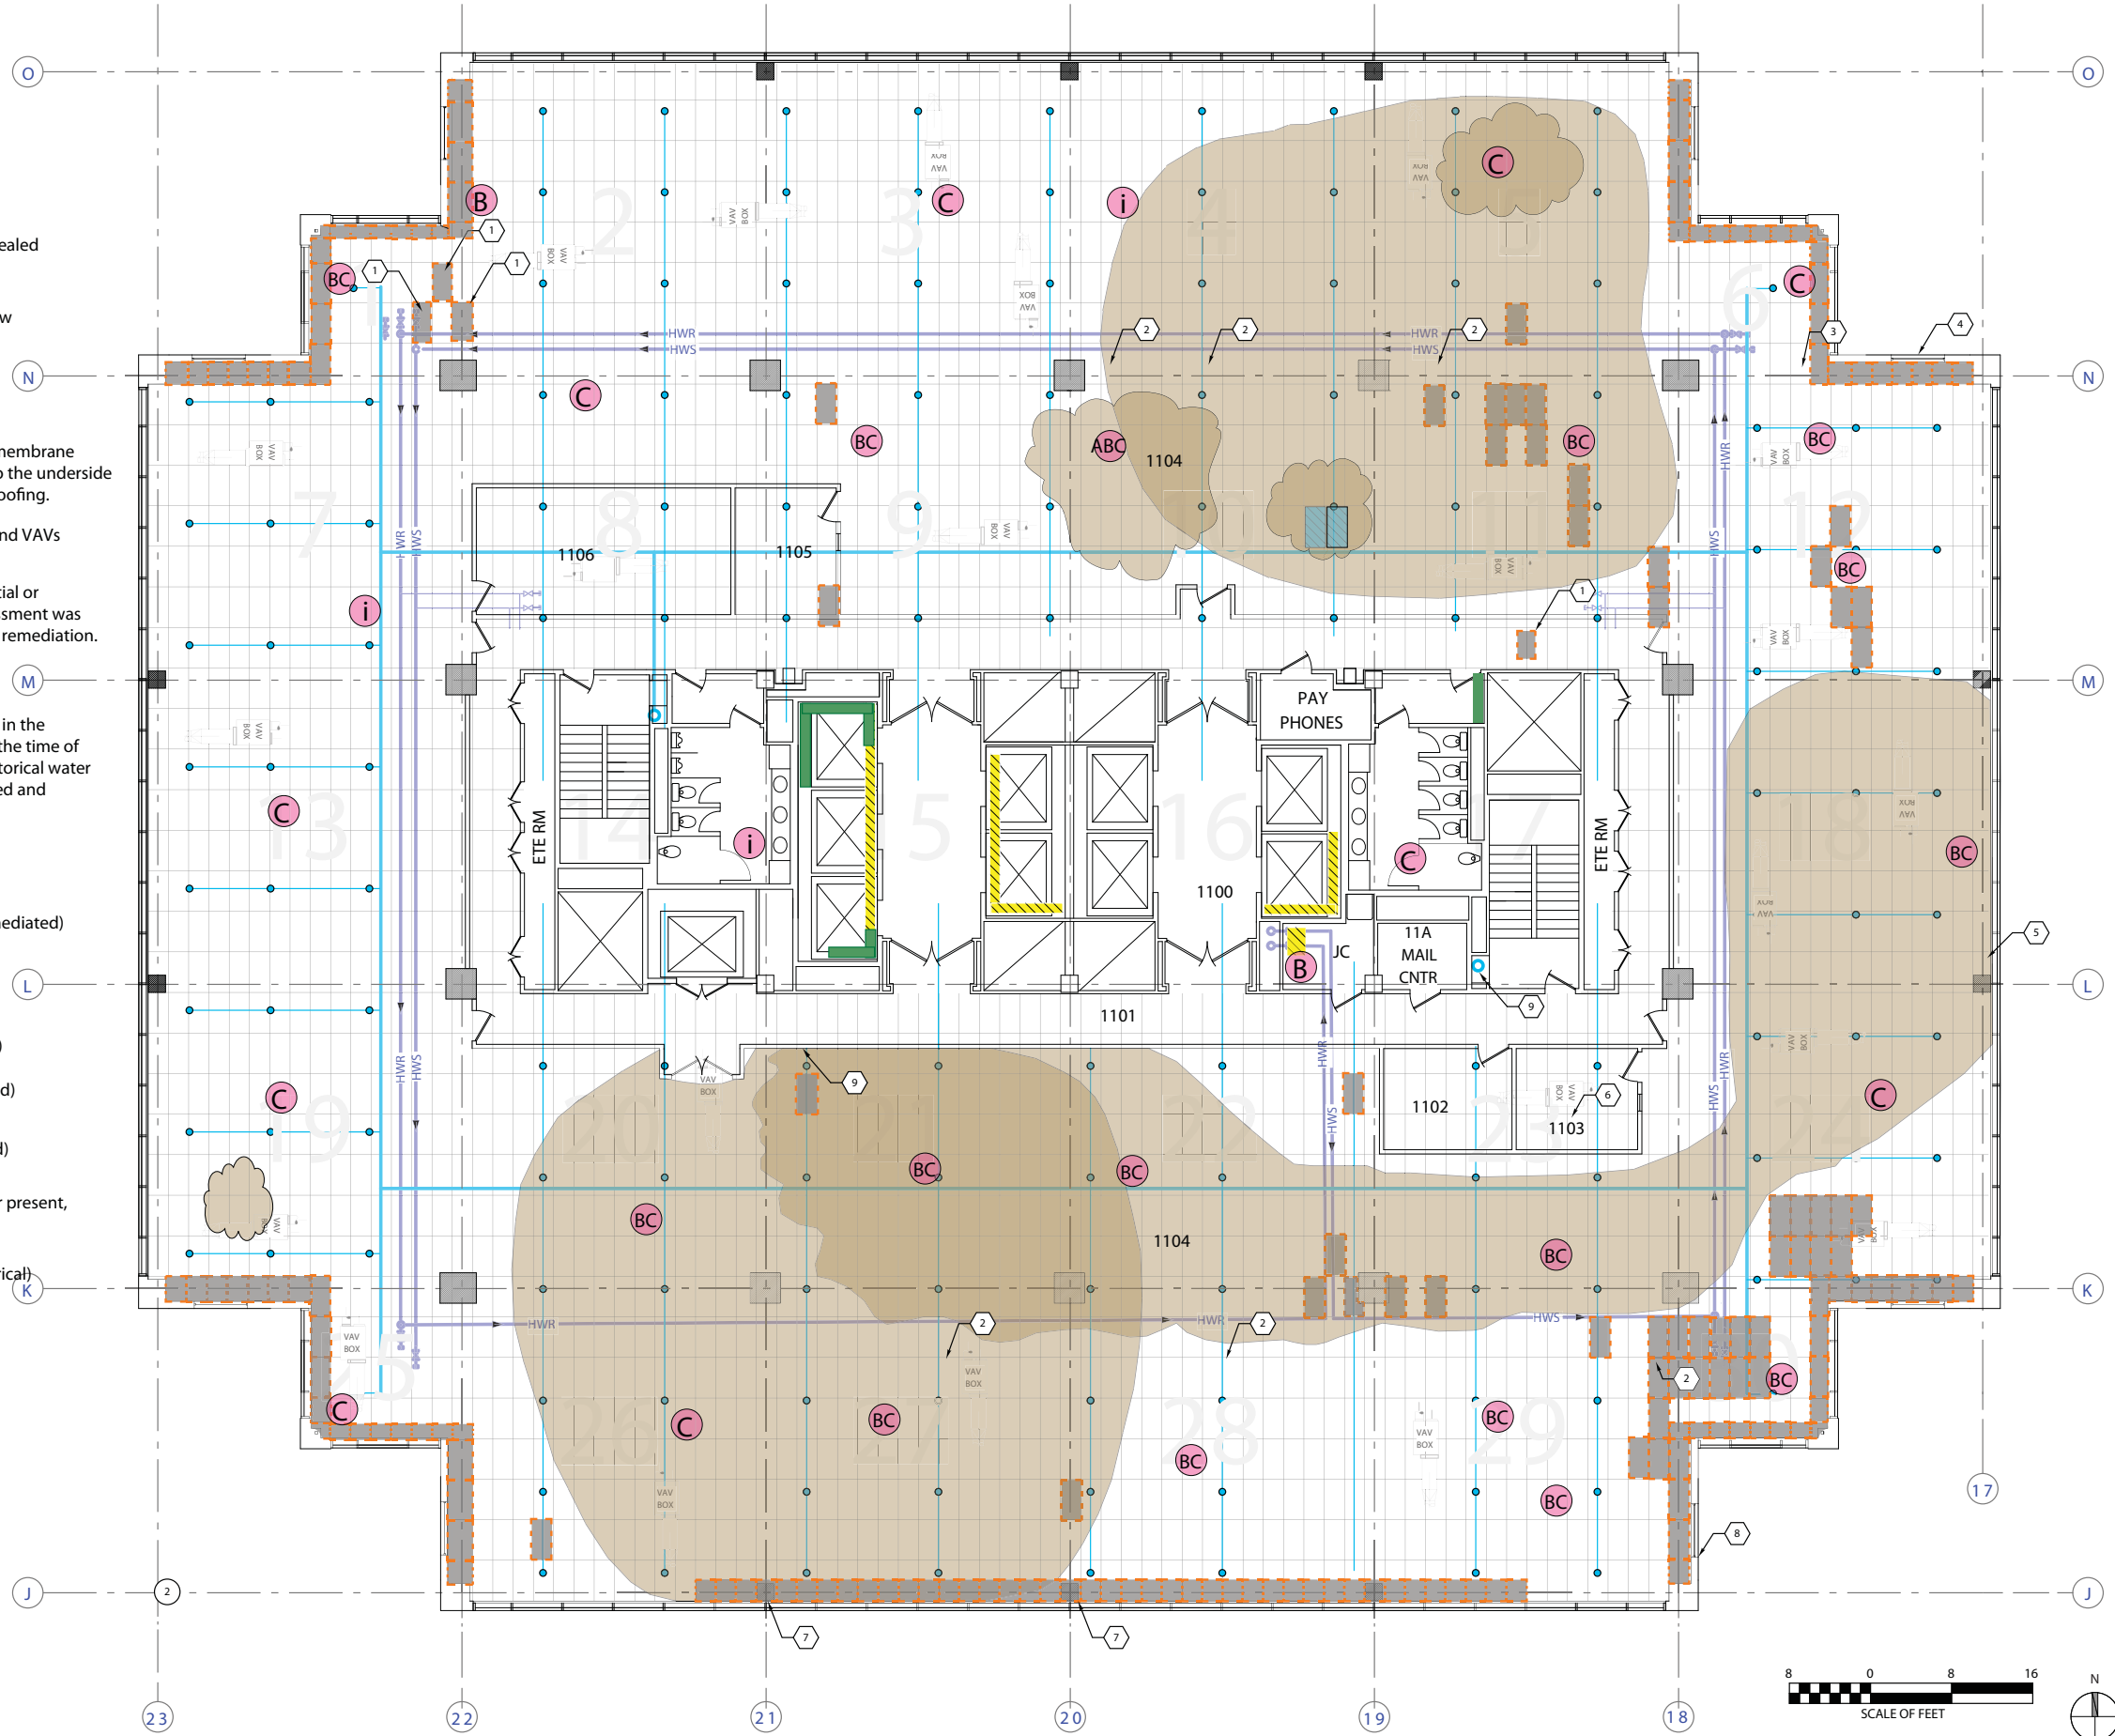
Figure 1

| May 2011 Column J-21, S Perimeter Wall | Inspection of stained ceiling tiles above ceiling. Stained fireproofing tested unremarkable. Stained ceiling tiles were replaced and stained fireproofing was marked. |
| July 2011 Column K-19 | Inspection and moisture testing of stained building materials caused by water intrusion from leaking cooling coils on the Mechanical Floor above. Wet gypsum board and associated insulation was removed. Remaining stained materials were marked. |

- 1 Historical water stain on sheetrock ceiling membrane above T-bar.
- 2 Water stain in light fixture
- 3 Water stain on ceiling tile
- 4 Water stain on punch-out window
- 5 Water damage at window
- 6 Visible mold growth in breakroom-sealed
- 7 Water damage at column
- 8 Damaged paint at punch-out window
- 9 Water stain on wall
